International Press-in Association

Volume 7, Issue 4 December 2022

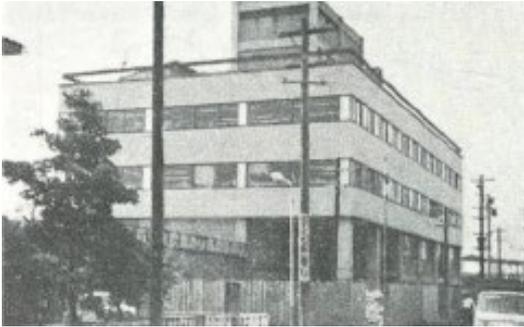
Photo1.1 Niigata Telecommunications Dept. Office Building<sup>1)</sup>

The Niigata Telecommunications Department Office Building (Photo 1.1) suffered damage with a maximum subsidence of 530 mm and a maximum tilt of 1/40 to 1/50, but no harmful cracks were found in the structure.

In this case of building restoration, in addition to the following reasons: (1) there was no damage that might hinder its continued use, (2) it was not desired to spend the cost of newly rebuilding it, (3) similar re-damage should be avoided, considering the construction cost and construction period, a method was adopted in which "as a structure to support the building, steel pipe piles were to be pressed into the foundations of the columns to raise the building horizontally". For the restoration, while using the second floor and above of the building, steel pipe piles with a length of 1.0m were added, and the number of steel pipe piles corresponding to the column load were pressed in with a jack. Concrete was placed on the top of the pile, which was used as a jack fulcrum when raising the building (Fig. 1.1).

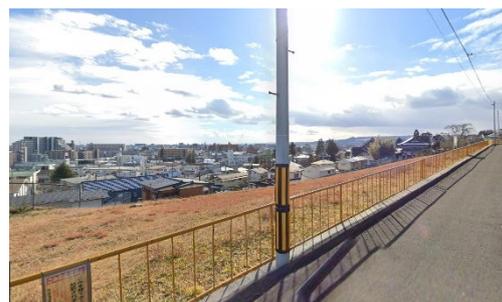
Photo 1.3 Affected area in Sendai City<sup>3)</sup>

In this earthquake, excavation surveys were actively carried out on the foundation piles of building structures, and it was clarified that (1) PC piles (prestressed concrete piles), especially AC piles (high-strength concrete piles), were significantly damaged, (2) in the case of the buildings which had damaged piles, the ground was not extremely soft, but slightly soft. On the other hand, in the hilly residential area near the center of Sendai city built after 1960, many landslides occurred on the embankment. It was reported, however, that there happened no damage from the Tohoku-Pacific Ocean Earthquake that occurred later in March 2011, in the area where the collapsed land had been turned into a green space and a concrete leaning retaining wall had been constructed with a steel pipe pile foundation that also had served as an earth retaining wall, as a restoration method. (Photo 1.3).

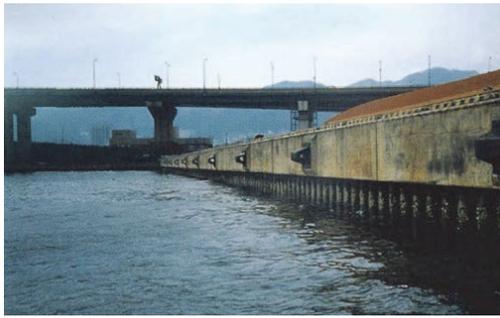
Photo 1.4 West side of Maya Wharf<sup>6)</sup>

At Port Island and Rokko Island, gravity caisson quays suffered severe damage, while pier structures suffered minor damage. “The Maya Wharf No. 1 Jetty West Quay (Photo 1.4)” was a seismic revetment with a horizontal design seismic intensity of 0.25. In the vicinity of the base of this jetty, a counterweight fill was placed on the sea side of the existing steel plate cell foundation, and further, a double-layer structure was adopted with a new quay-wall of steel pipe sheet piles with battered piles installed (Fig. 1.2). In addition, the tip of the pier had a very solid double-foundation quay with a steel plate cell on the land side and a caisson on the sea side, and although there were some cracks in the concrete due to uneven subsidence at the connection part between the horizontal pier and the caisson, there was no functional problem after the disaster.

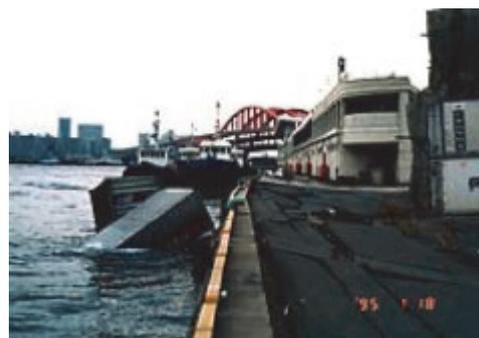
Photo 1.5 Shinko No.4 Pier (-12m quay)<sup>8)</sup>

Shinko Pier No. 4 (-12m quay) (Photo 1.5), located at the base of the Shin-Kobe Ohashi Bridge leading to Port Island, had been used as an international passenger berth. Regarding the restoration method, as there were constraints because it was in the water area in front of the slip (between jetties), and the shed was close behind, a method was adopted in which steel pipe sheet piles were to be placed in front of the existing caissons, and underwater concrete was to be filled between them.

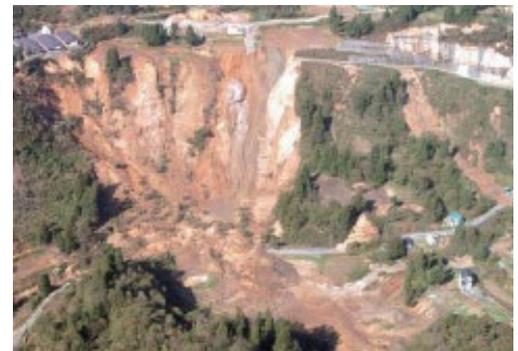
Photo 1.6 Landslide at Former Yamakoshi Village<sup>9)</sup>

Due to the rainfall caused by the typhoon that had passed three days before the earthquake, landslides occurred one after another on the slopes of the hills. In the former Yamakoshi Village, houses collapsed with earth and sand (Photo 1.6), and there was damage caused by the outflow of irrigation water from Nishikigoi farming ponds making use of terraced rice fields. In mountainous tributaries, collapsed sediment clogged river channels, forming natural dams that cut off traffic routes, leaving many communities isolated.

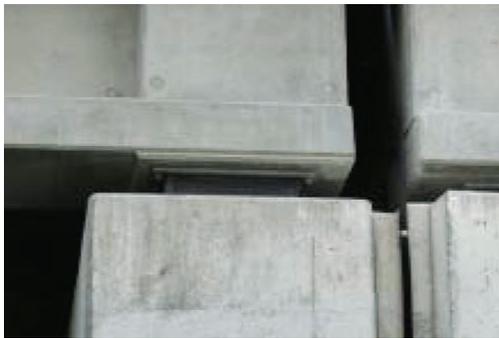
Photo 1.9 Bearing deformation<sup>11)</sup>

No major deformation was found in the main bodies of the bridge foundations, except for the bridges whose superstructure and substructure were washed away by the tsunami. As for the bridges that were washed away, it was assumed that the damage to the foundations themselves due to the seismic motion was minor. As damage to the foundation bodies due to the earthquake motion, although some deformation of the bearings and cracks on the embankment slopes at the abutments were confirmed, no major deformation was confirmed in the foundation bodies, and they were found almost sound (Photo 1.9).

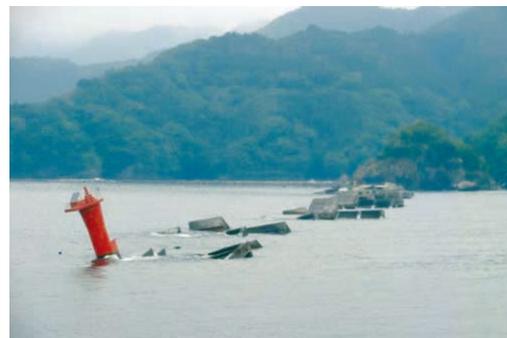
Photo 1.10 Damage to Kamaishi Bay mouth breakwater<sup>10)</sup>

The post-earthquake tsunami caused major damage to breakwaters and seawalls in many areas of the Tohoku region, including collapse, etc. (Photo 1.10), but damage to quay walls and seawalls was limited.

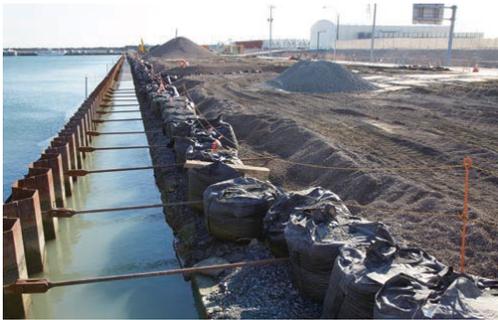
Photo 1.11 New Installation of steel sheet piles of designed water depth - 7m quay<sup>13)</sup>

While restoring the original shape, a design was made for the purpose of raising the height of the subsidence, and regarding the steel sheet piles that caused the normal deviation, new sheet piles were installed slightly forward the existing sheet piles (Photo 1.11). A new steel pipe pile was also installed for the H-shaped steel that had collapsed in the existing apron. A steel sheet pile was driven at 1.7m forward the normal line to the old revetment, Steel piles with 600 mm in diameter and 12 to 17 m in length were driven into the apron area, and the front steel sheet piles were tied with about 13m long tie rods to serve as an anchor (Fig. 1.3).

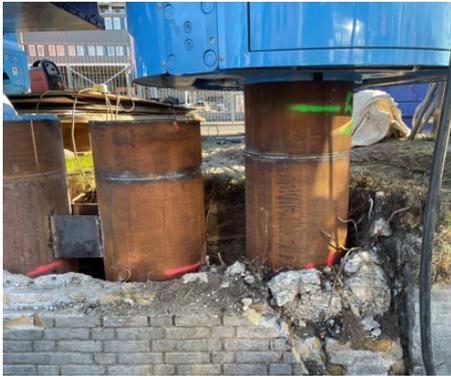
Fig.1 Under construction & Cross section

- Construction length: approx. 44.0 m
- Pile: steel pipe pile  $\phi 609.6$
- Pile length  $L=9.5$  m

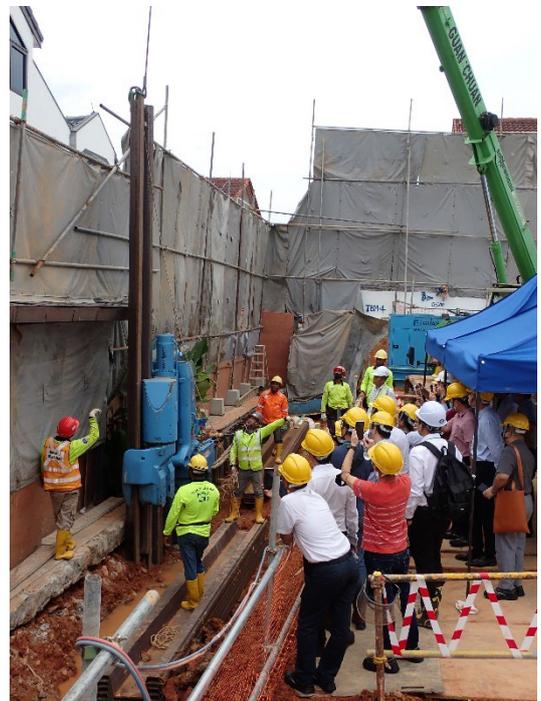
Photo 3 Site Visit

After the seminar, 46 people attended a live site press-in piling demonstration. The project is the construction of a private 2-storey house. On the project, the press-in piling method is being utilized to install Zero Sheet Piles (NS-SP-J Sheet Piles) which form an approximately 12m x 27m rectangular shape retaining wall, for the construction of a single-level underground parking lot Right on the boundary lines to maximize land use, 9m long sheet piles were being installed by the Zero Piler. Type of the Press-in Piling Method is known as the “Zero Clearance Method”. The sheet piles are to be left in place as permanent basement walls, in conjunction with cast in-situ concrete walls. The ground condition is soft-medium stiff clay (old alluvium) with the maximum SPT *N* value of 14. The Standard Press-in Mode (no driving assistance used) was utilized taking the ground conditions into account.

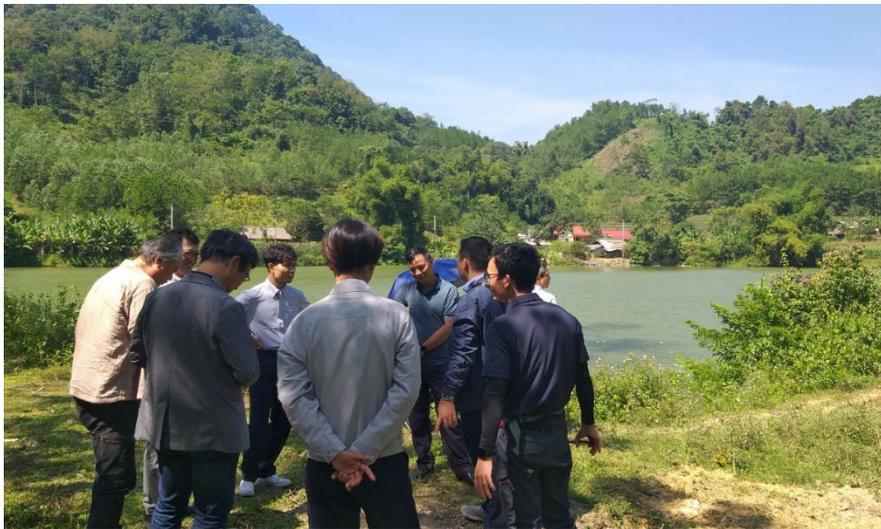
Photo 3. Site visit to Keo Coi reservoir, Na Ri district, Bac Kan province, Vietnam.

Apart from attending the workshop, the delegates and experts also conducted a site visit to the Keo Coi Irrigation Reservoir in Na Ri district, Bac Kan province (Photo 3). This project is expected to apply Press-in Technology to handle water leakage through the dam and increase the overall stability of the structure.
